**TEST REPORT No. 370576**

**railing named****“ALURAIL FLORA CROCUS 8030 TOP WITH PICKETS”**

**horizontal linear static loading in accordance with  
standard UNI 10806:1999 and DM Infrastrutture  
17 January 2018, and 50 kg soft body dynamic loading in  
accordance with standard NF P01-013:1988**

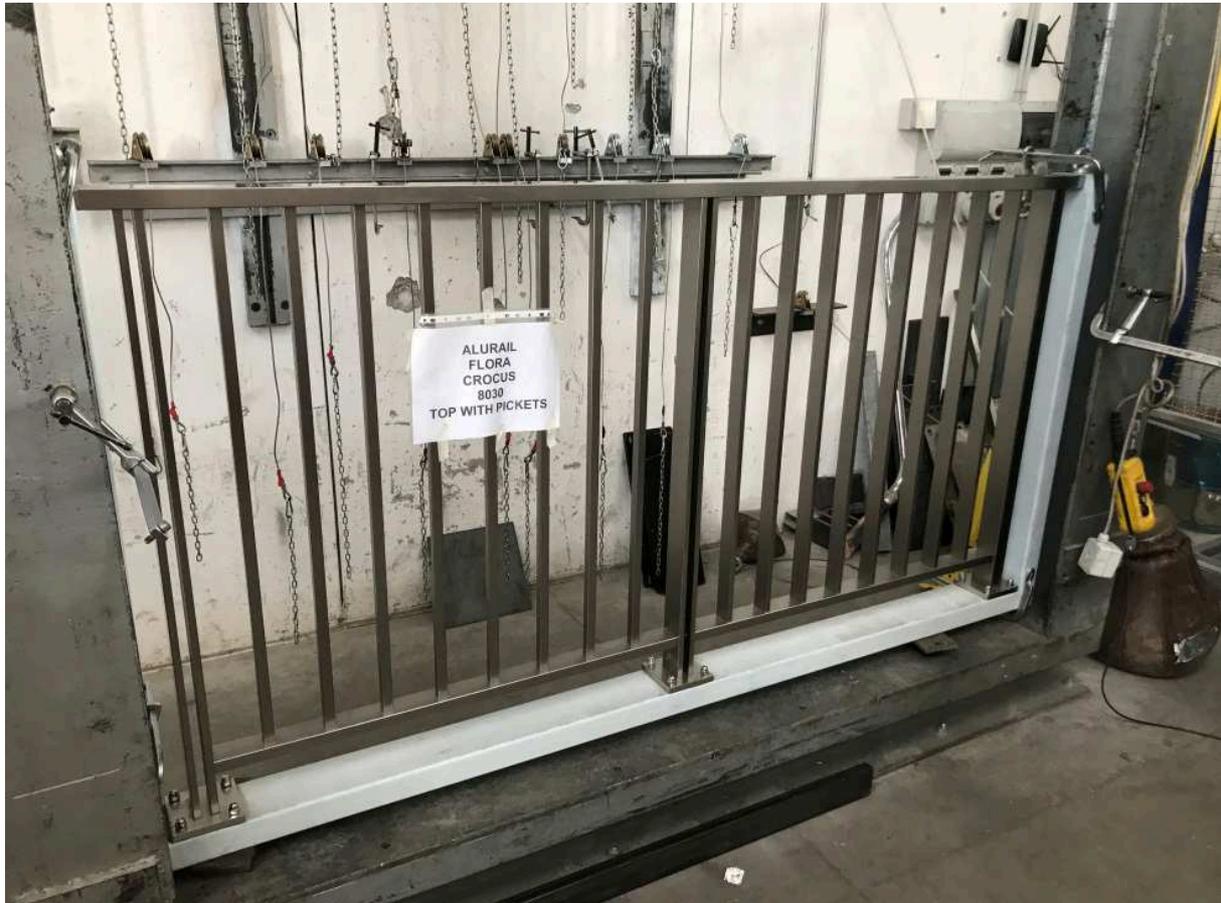
The item under evaluation consists of a aluminum railing, having the characteristics shown in the following table.

<b>Width</b>	2139 mm
<b>Height from floor level</b>	1100 mm

**Item photograph**

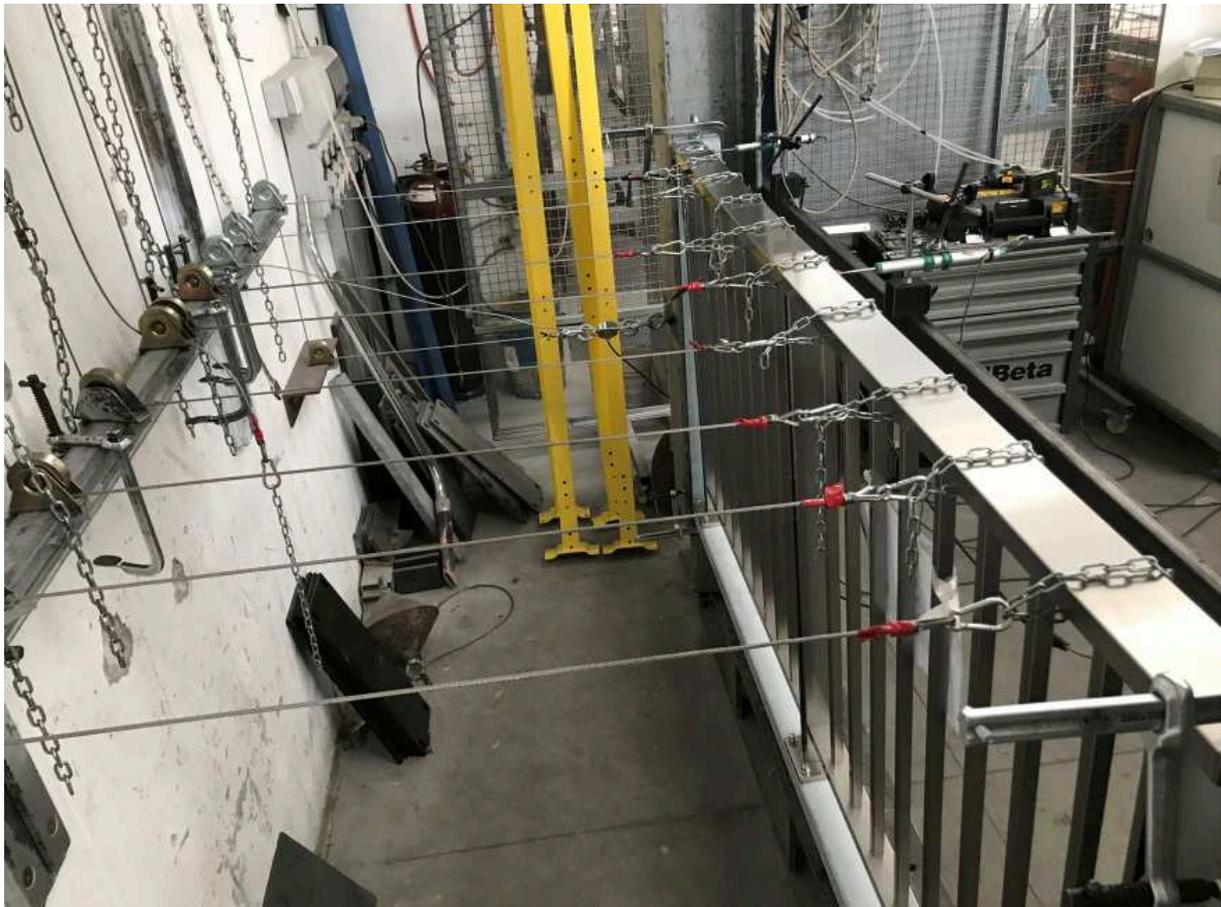
Applied load per unit area [kN/m]	Deflection under load at the measure point			Residual deformation at the measure point			Effect
	A [mm]	B [mm]	C [mm]	A [mm]	B [mm]	C [mm]	
2,0	34	38	31	1	1	1	no damage impairing item functionality

Photograph of the item subjected to linear static loading

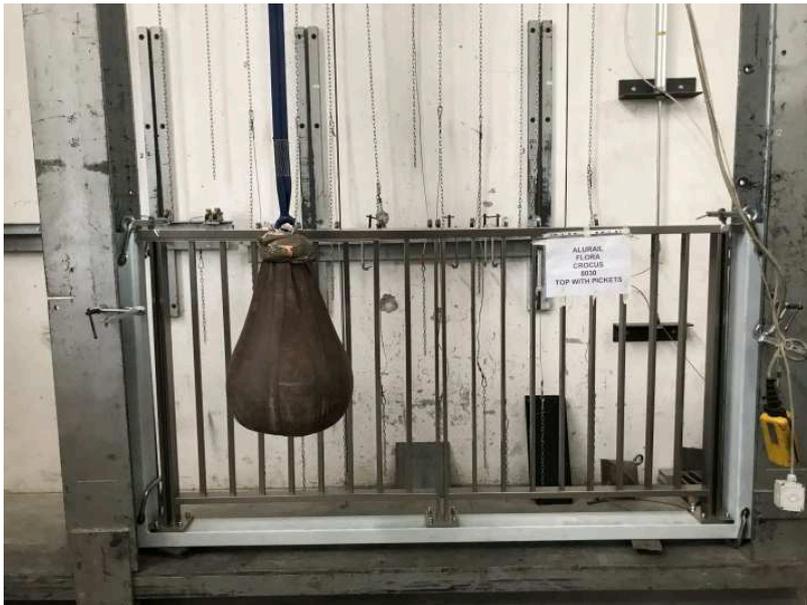
Impact area	Drop height [m]	Energy [J]	Result
infilling centre	1,2	589	slight deformation not impairing item functionality*

No gaps were formed between the bars of sufficient size to allow the passage of the gauge specified in figure 7 of standard NF P01-013:1988.

Item photographs after the impact

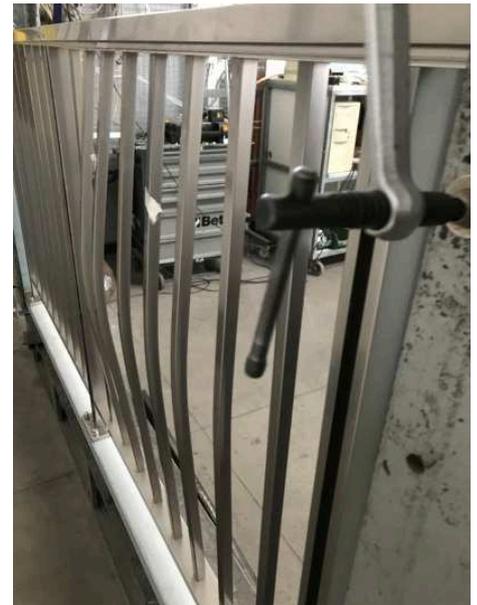
Deformation detail

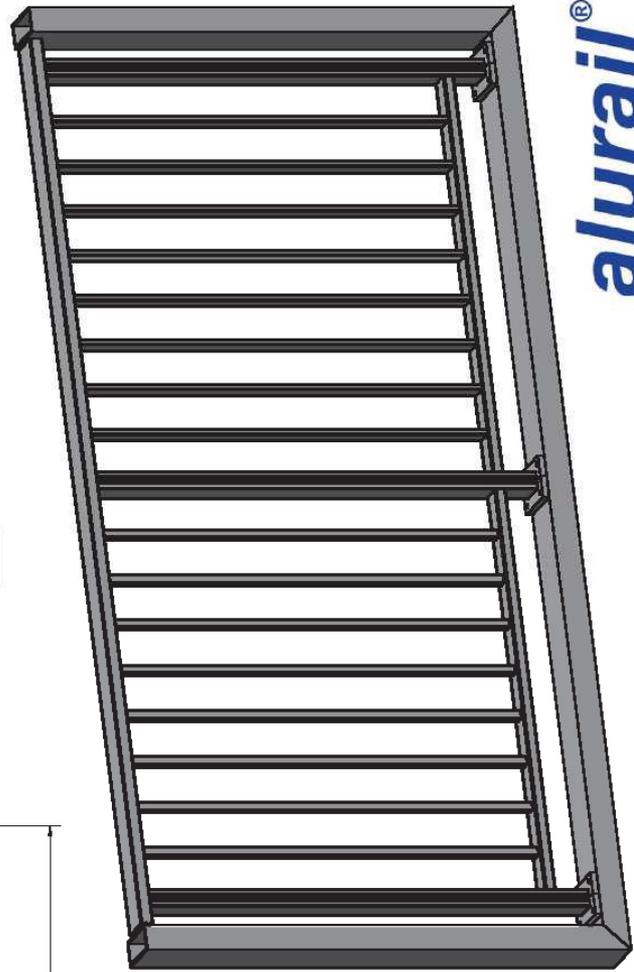
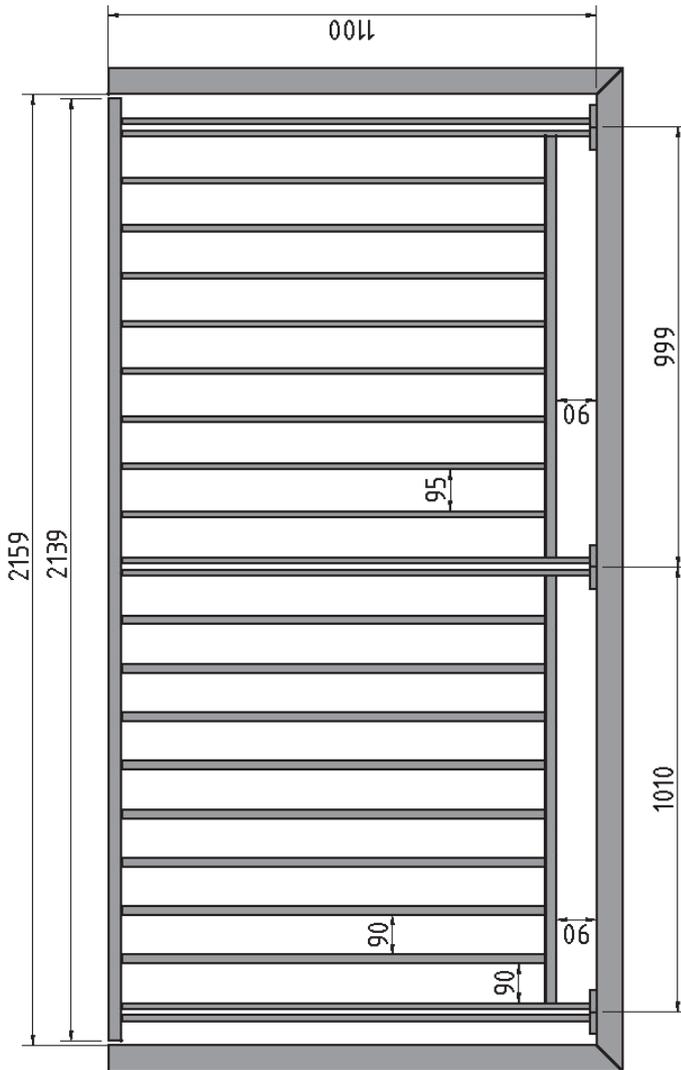
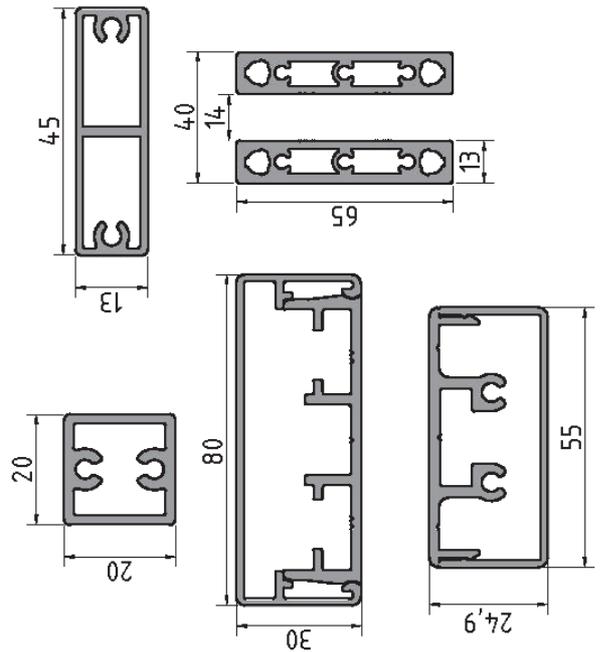
ALURAIL FLORA  
CROCUS 8030  
TOP WITH PICKETS

Further details of item specifications can be seen in customer-supplied schematic drawing in annex "A".
