## TEST REPORT No. 392805

**railing named**
**"RAILING SYSTEM 8900 TOP MOUNTING 88.2"**

**resistance to horizontal linear static loading according to D.M. 17 January 2018 and standard UNI 10806:1999 and resistance to dynamic loading according to standard UNI 10807:1999 and UNI EN 14019:2016**

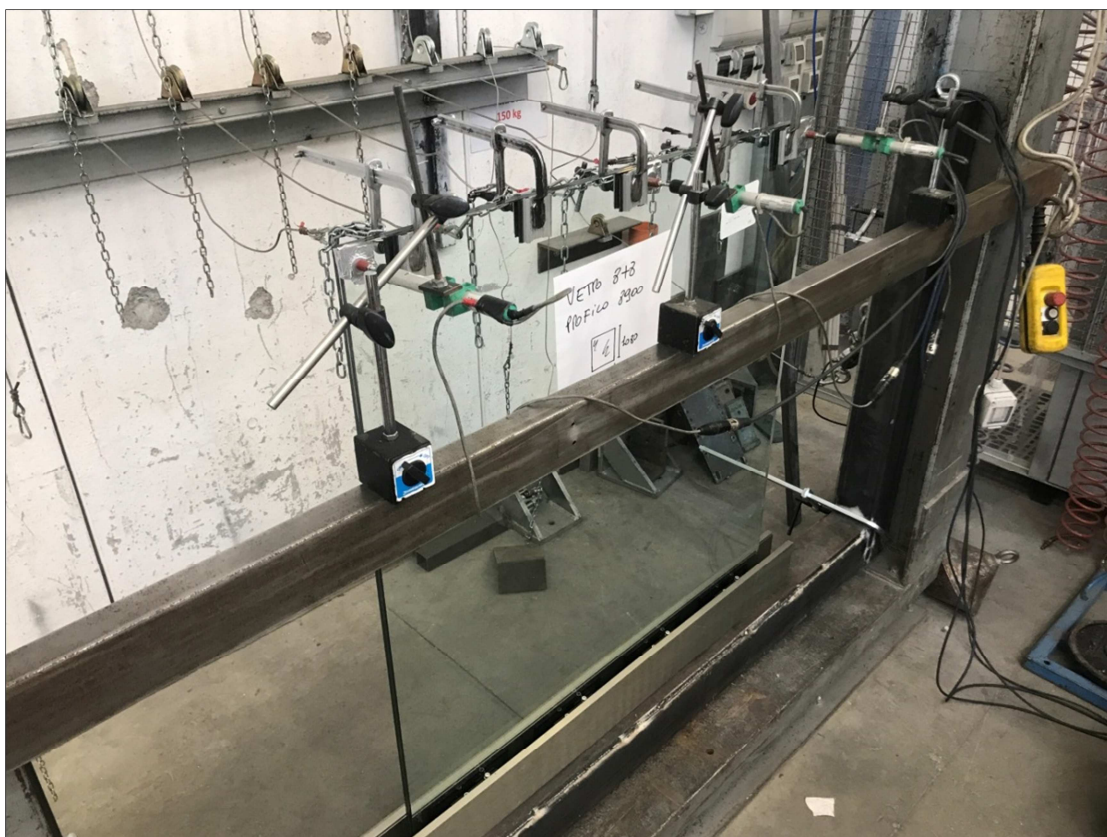
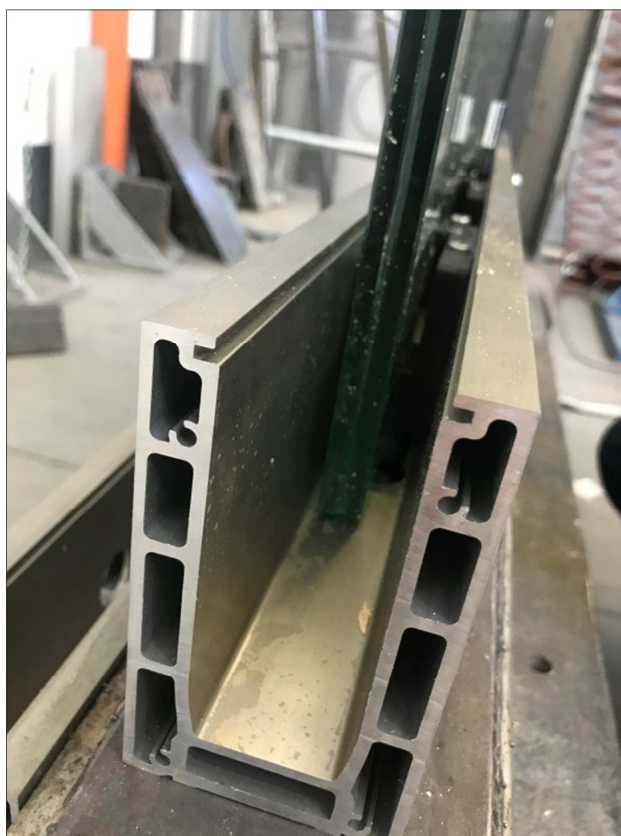
**Photographs of the Item**

The item under examination consists of laminated tempered glass railing with aluminium structure, having the following characteristics:

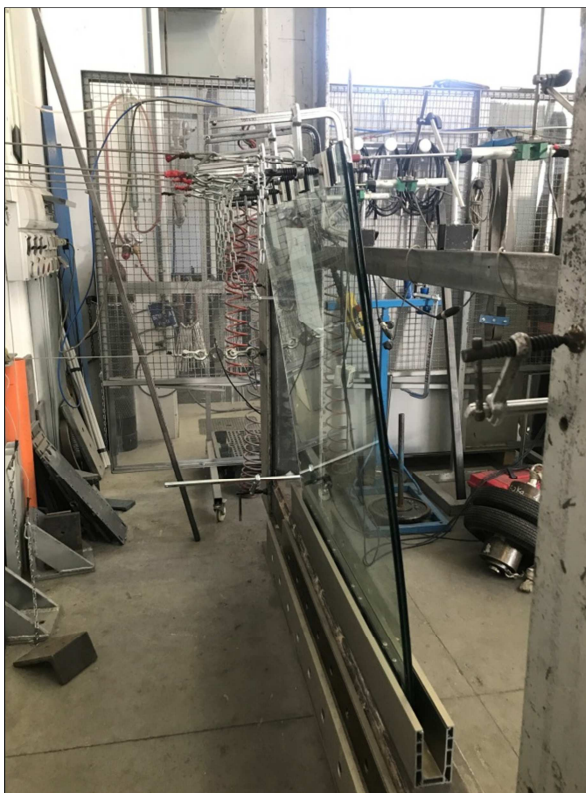
Applied load [kN/m]	Deflection whilst loaded			Permanent deflection			Result
	in point "A" [mm]	in point "B" [mm]	in point "C" [mm]	in point "A" [mm]	in point "B" [mm]	in point "C" [mm]	
3,0	129	129	126	19	17	18	no damage

**Photograph of the item undergoing horizontal linear static loading**

The three digital displacement transducers were positioned on the item in order to read the relative displacement of the upper edge of the glazing, two at the ends of the object (points "A" and "C") and one in the middle between them (point "B"). The item was subjected to operative horizontal linear static load apportioned as defined by the Customer, on the upper edge of the glazing.

Once reached the test load, it was maintained for at least 15 min, recording then the deformation under load. Afterward the load was progressively removed down to zero. The residual deformations were recorded after a wait of at least 5 min.

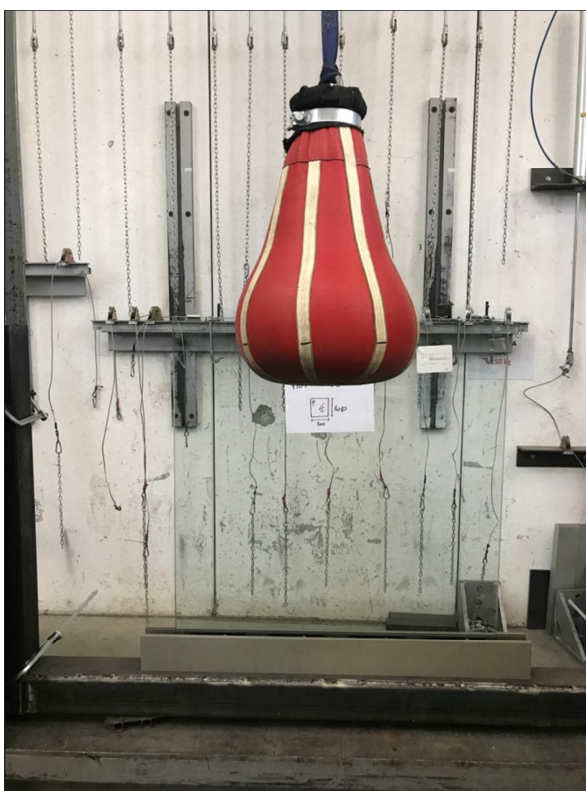
Dynamic loading according to standard UNI 10807:1999			
Impact area	Drop height [mm]	Nominal energy [J]	Result
center of glazing	300	150	no damage
center of the upper edge of the glazing	300	150	no damage

**Photograph of the item  
after impact on the border of the glazing with dynamic load according to standard UNI 10807:1999**

All impacts were made by releasing the impactors so that they fall from a specified height with a pendulum movement and without initial velocity. The impactors were hung by an inextensible pendulum wire of negligible mass so that when at rest they made contact with the point of intended impact. After each impact, the impactors were prevented from hitting the item again after bouncing.

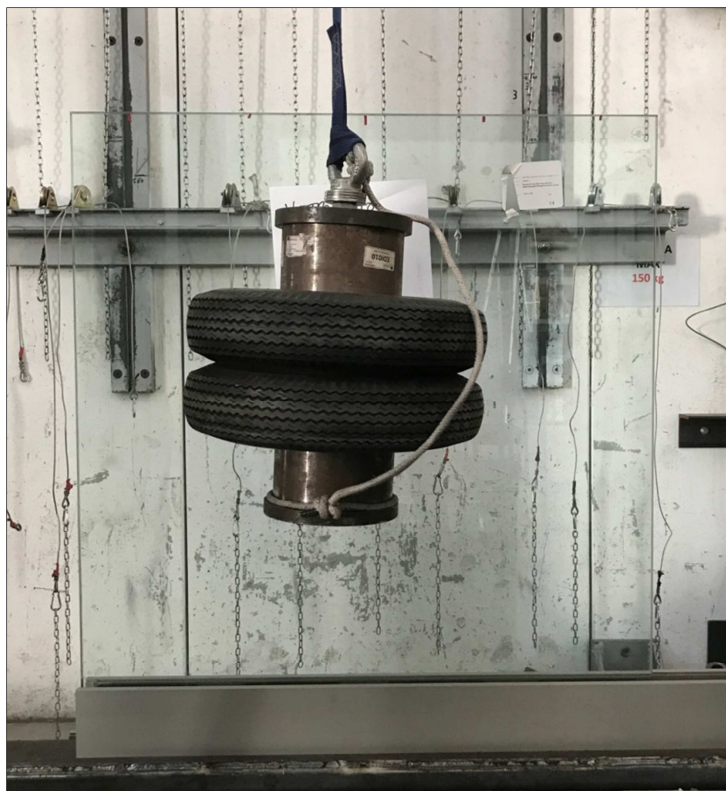
Dynamic loading according to standard UNI EN 14019:2016			
Impact area	Drop height [mm]	Nominal energy [J]	Result
center of infill	950	466	no damage

**Photograph of the item  
after impact on the center of the glazing with dynamic load according to standard UNI EN 14019:2016**
